NACA RM E55H02

RESEARCH MEMORANDUM

FACTORS THAT AFFECT OPERATIONAL RELIABILITY
OF TURBOJET ENGINES

By Lewis Laboratory Staff

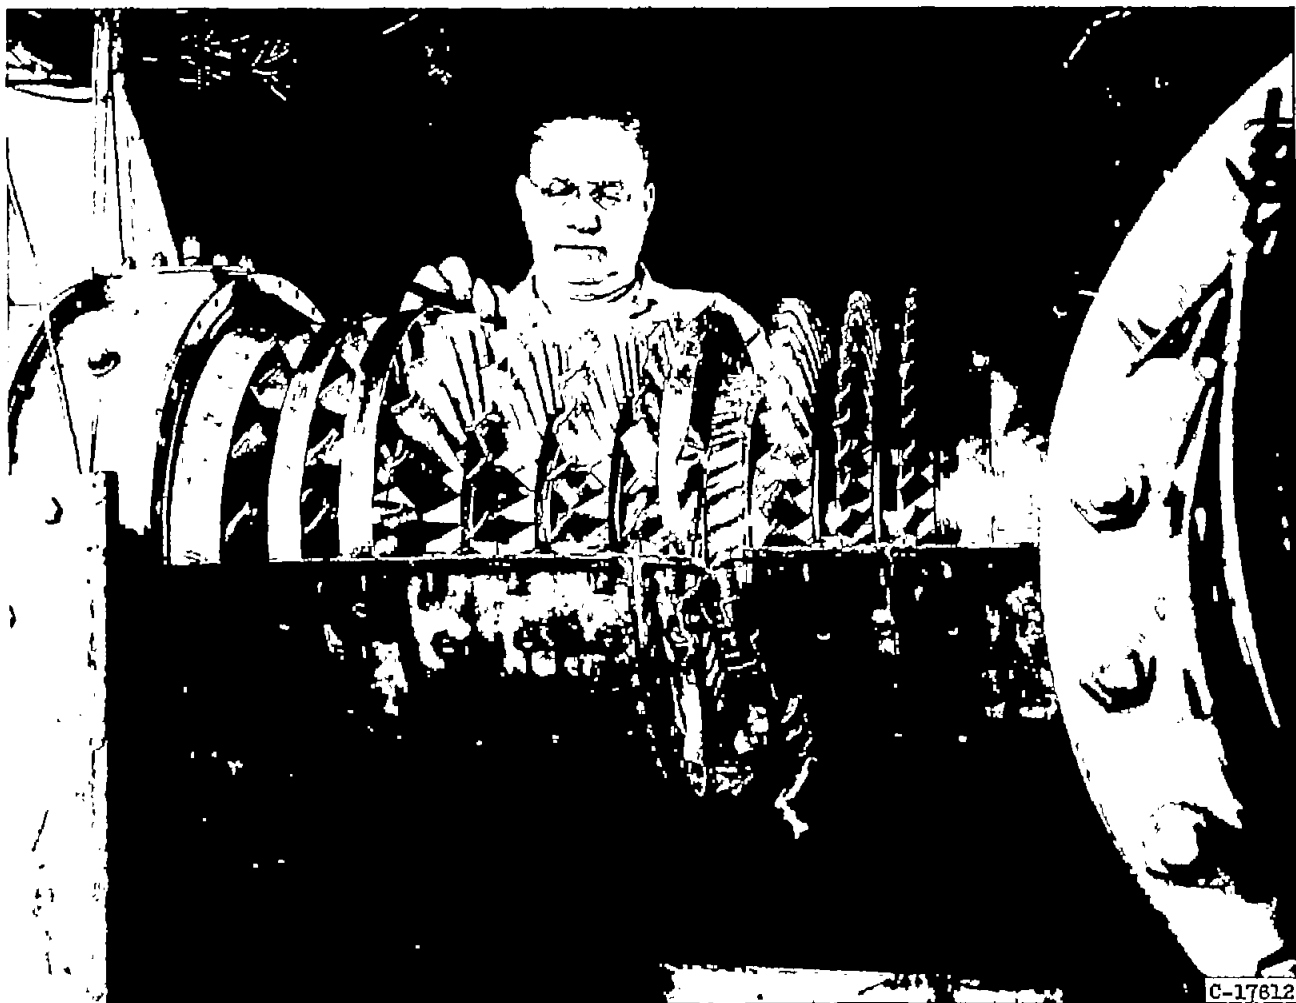
Figure 1. - Typical axial-flow-compressor failure resulting from fatigue of one first-stage blade.

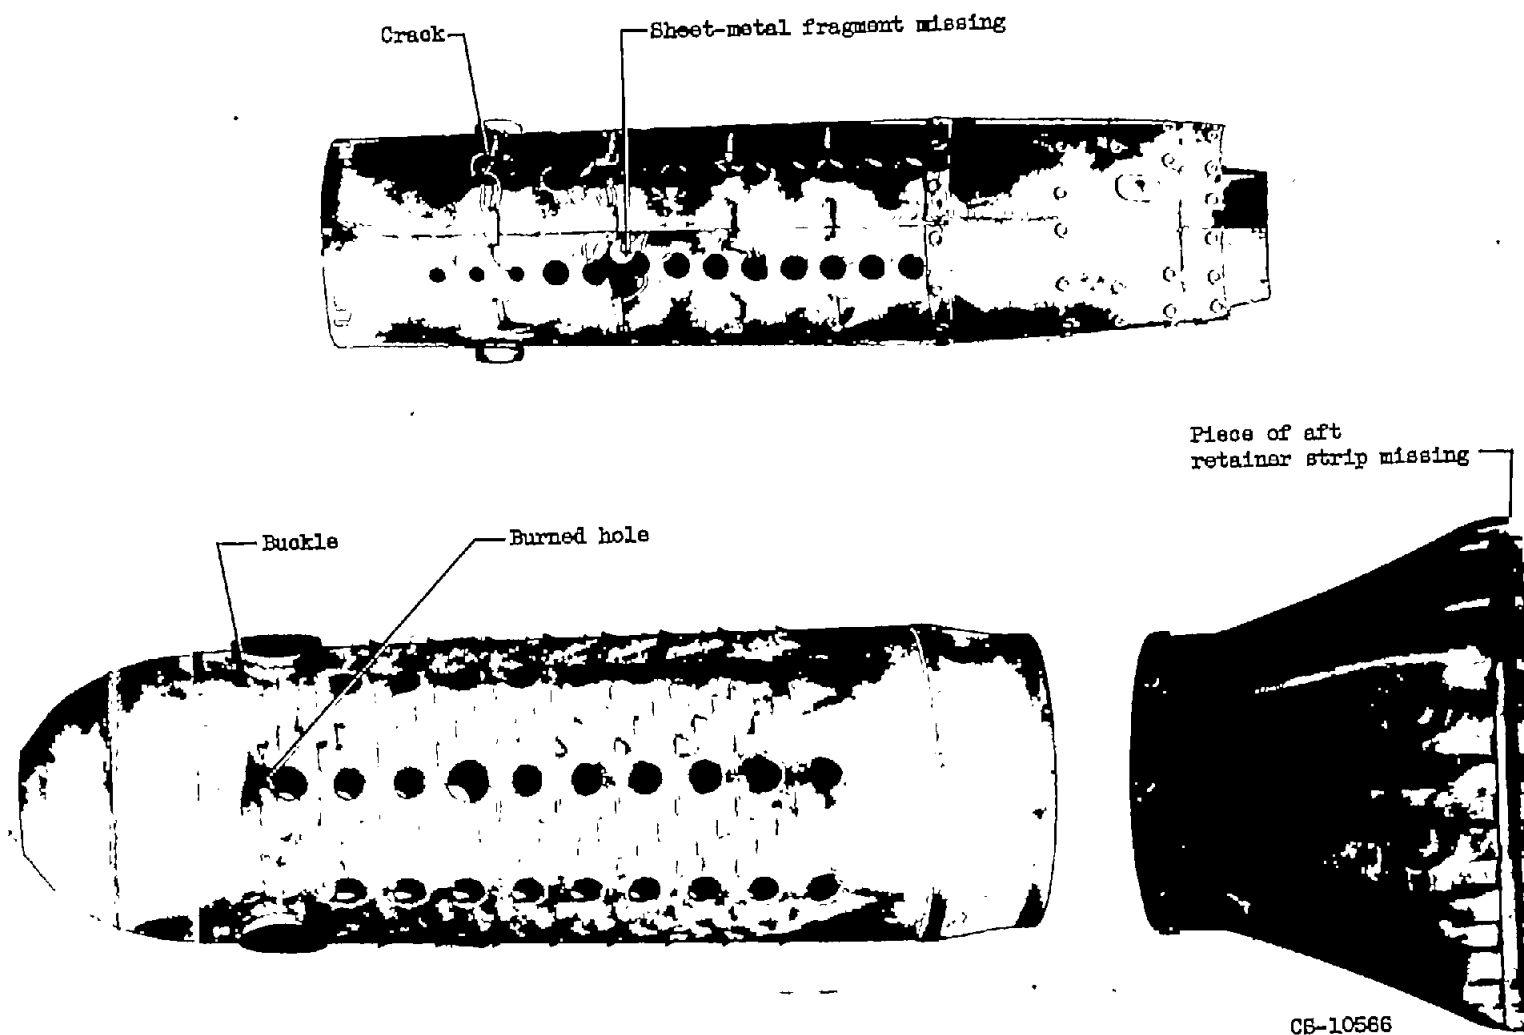
Figure 4. - Typical failures in turbojet liners.

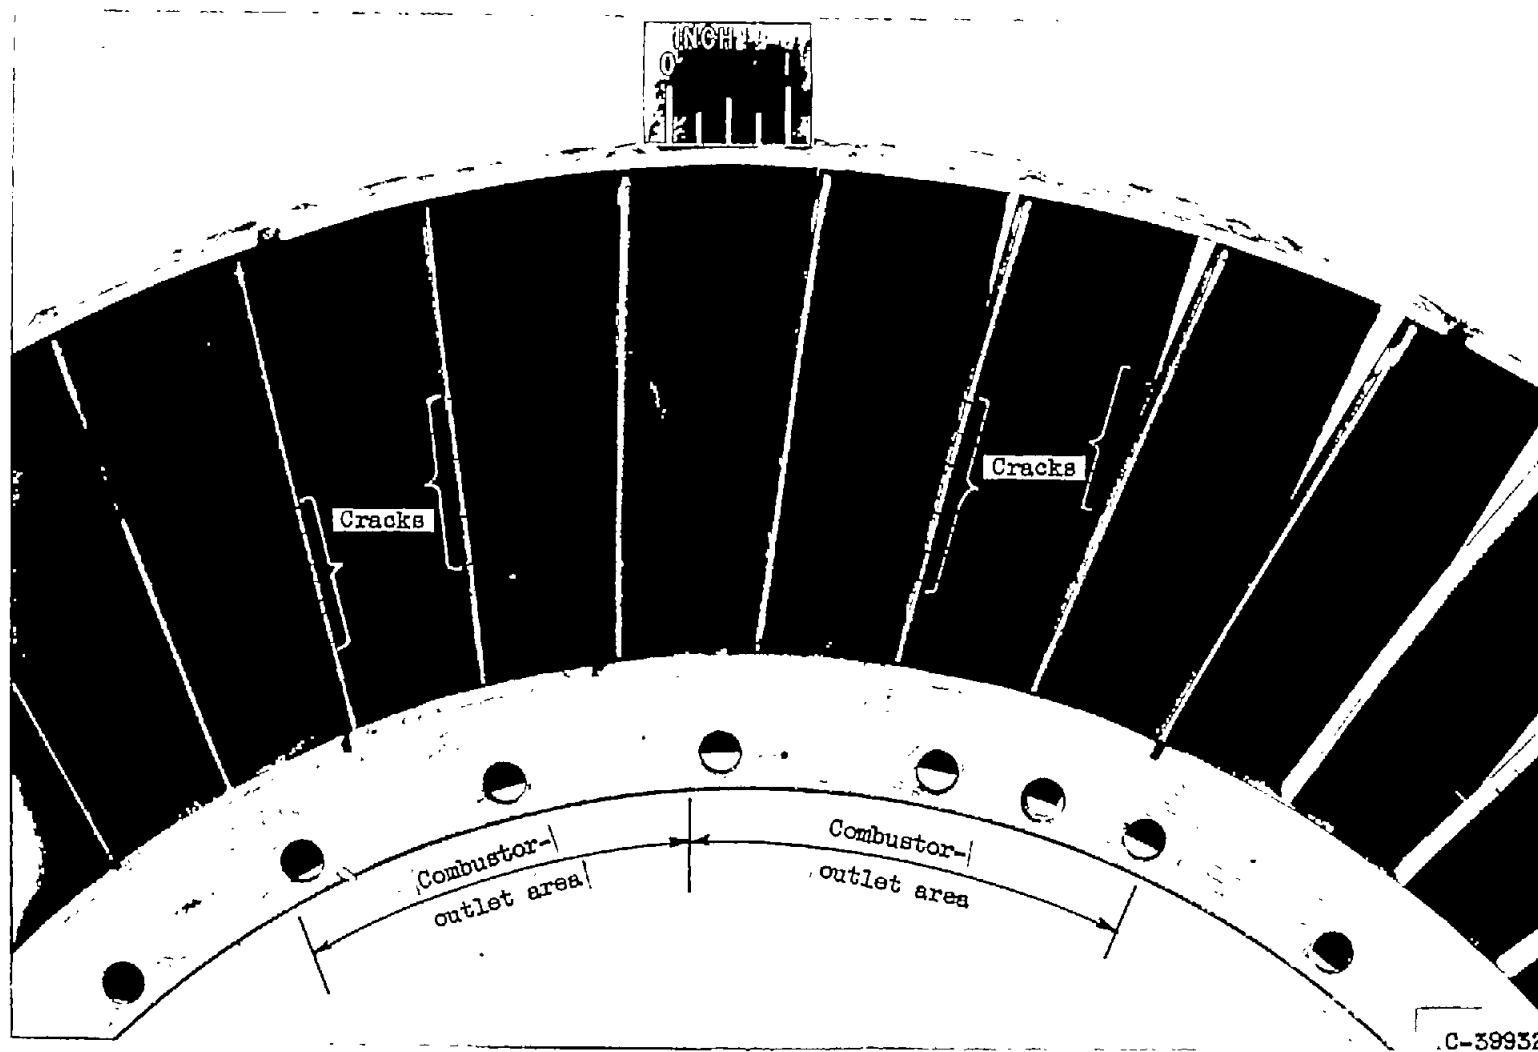
(a) Upstream edges.

Figure 3. - Nozzle diaphragm showing cracks on edges of vanes (ref. 9).

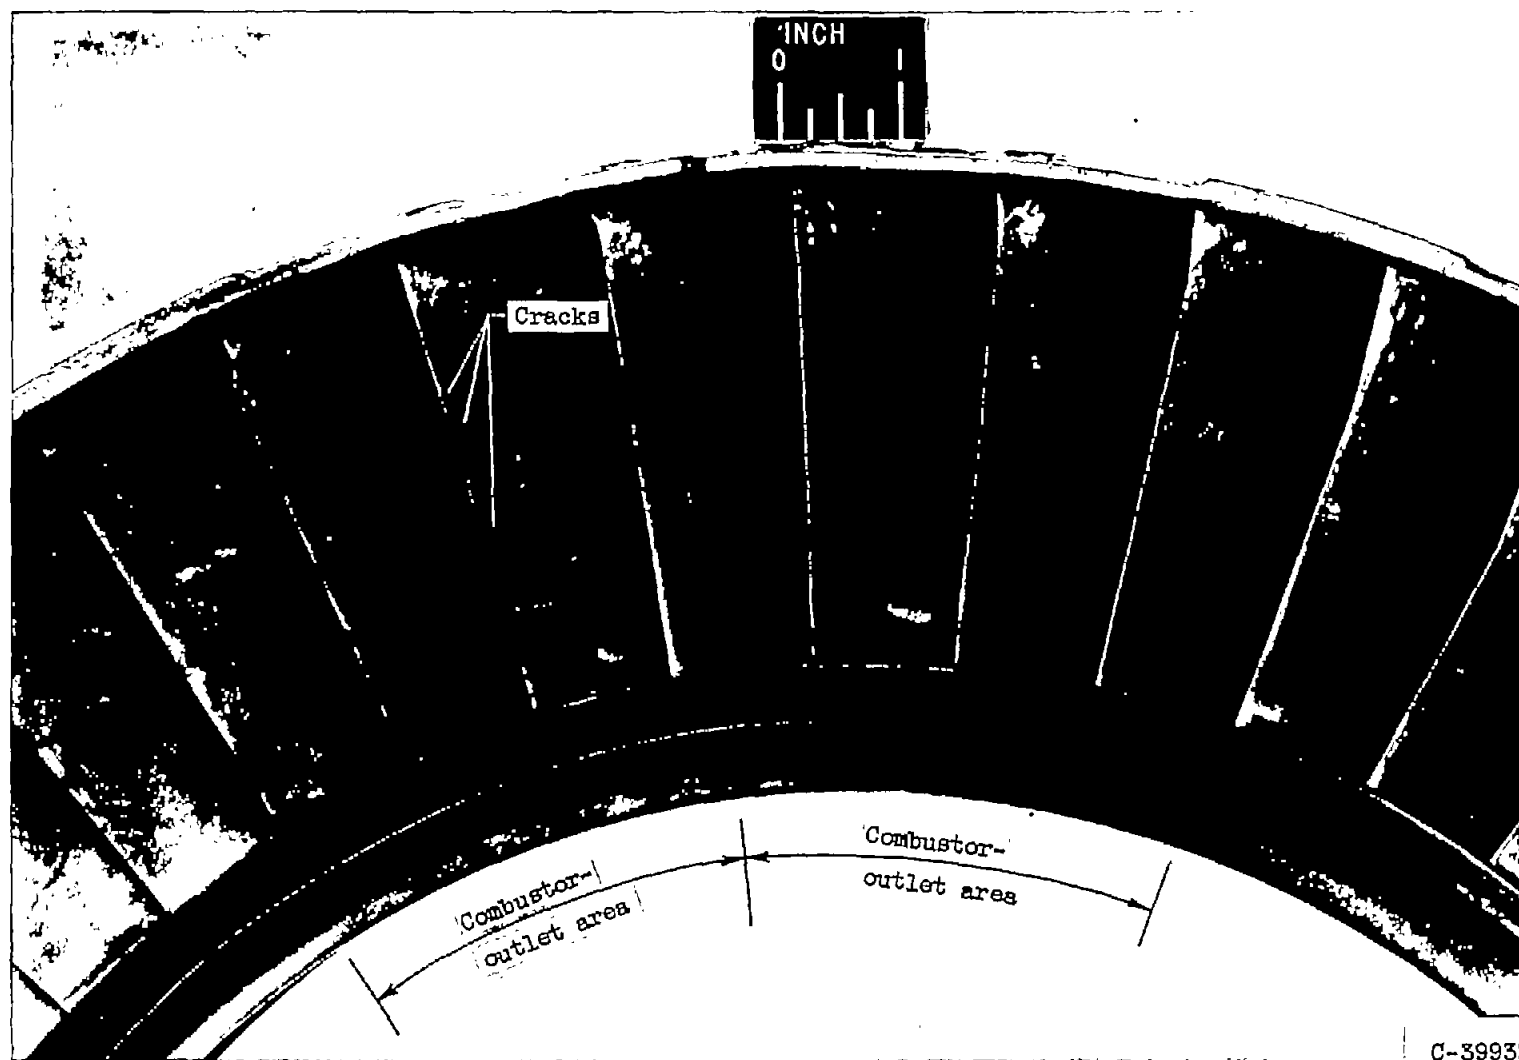
(b) Downstream edges.

Figure 3. - Concluded. Nozzle diaphragm showing cracks on edges of vanes (ref. 9).

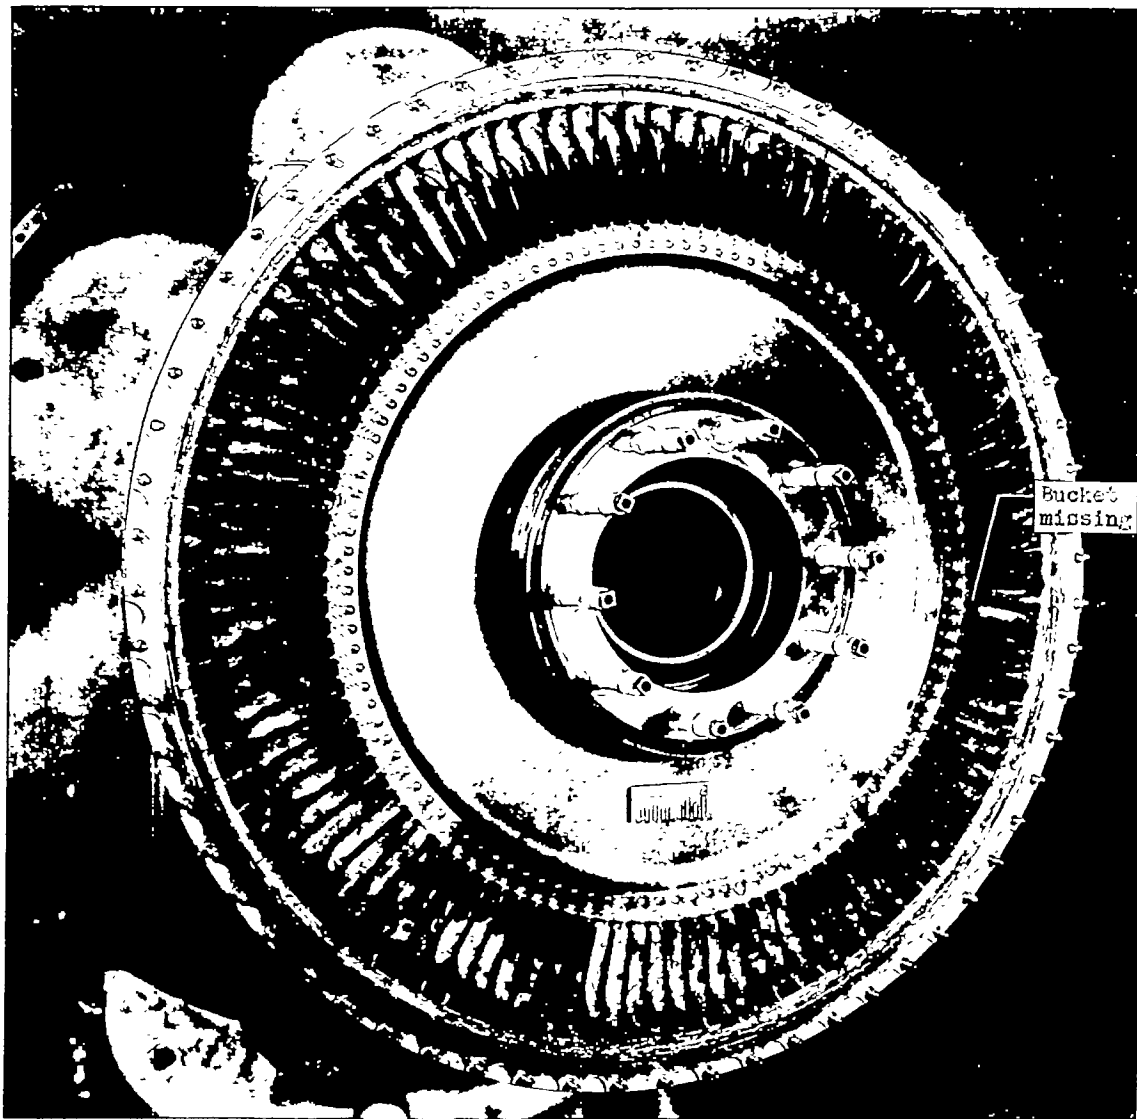
(a) Second stage of turbine; all bucket shrouds gone.

Figure 2. - Damage to three-stage turbine resulting from failure of second-stage bucket.

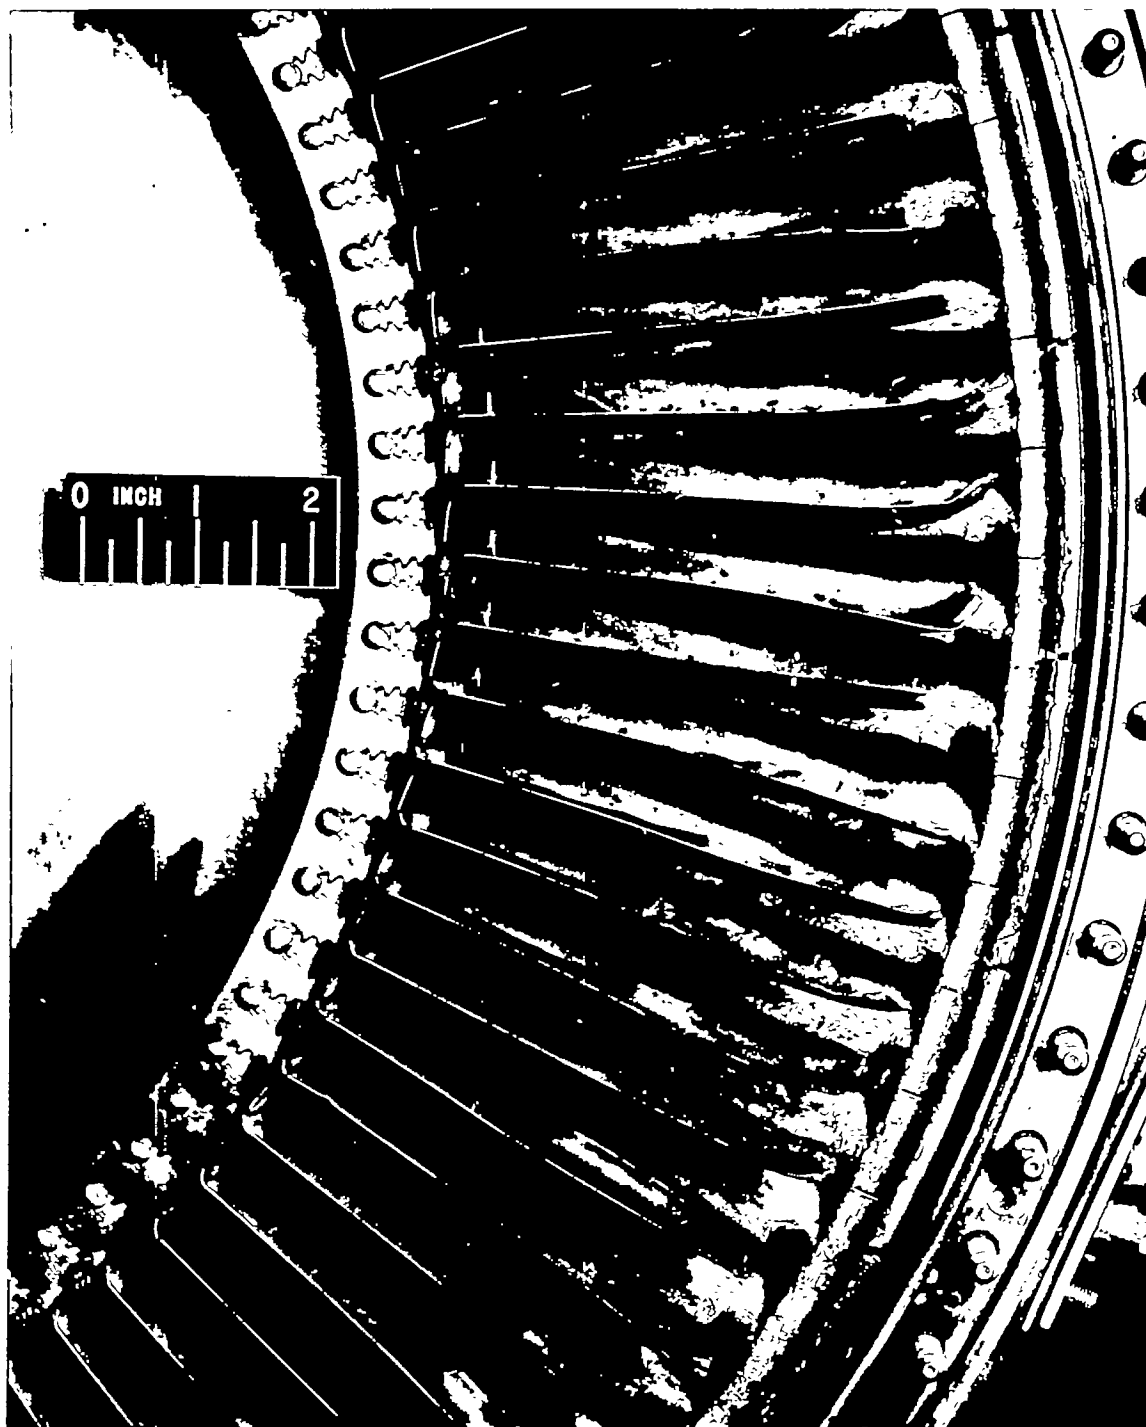
(c) Third stage of turbine; all bucket shrouds gone.

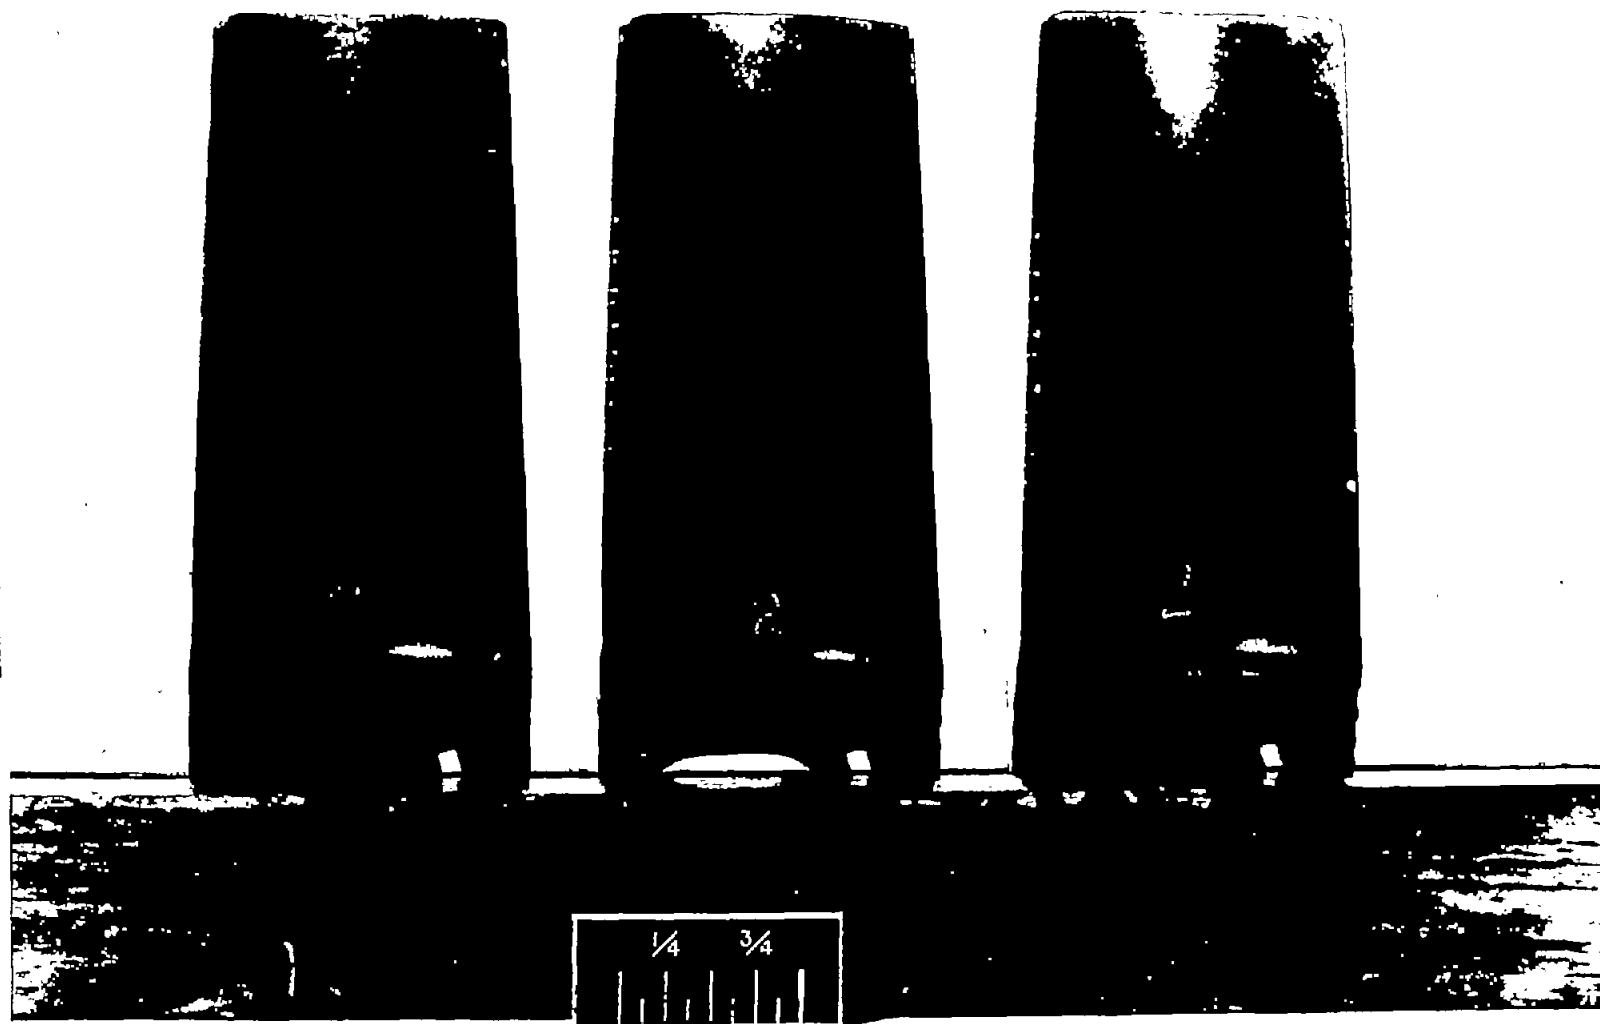
Figure 24. - Leading-edge cracking from repeated thermal gradients.

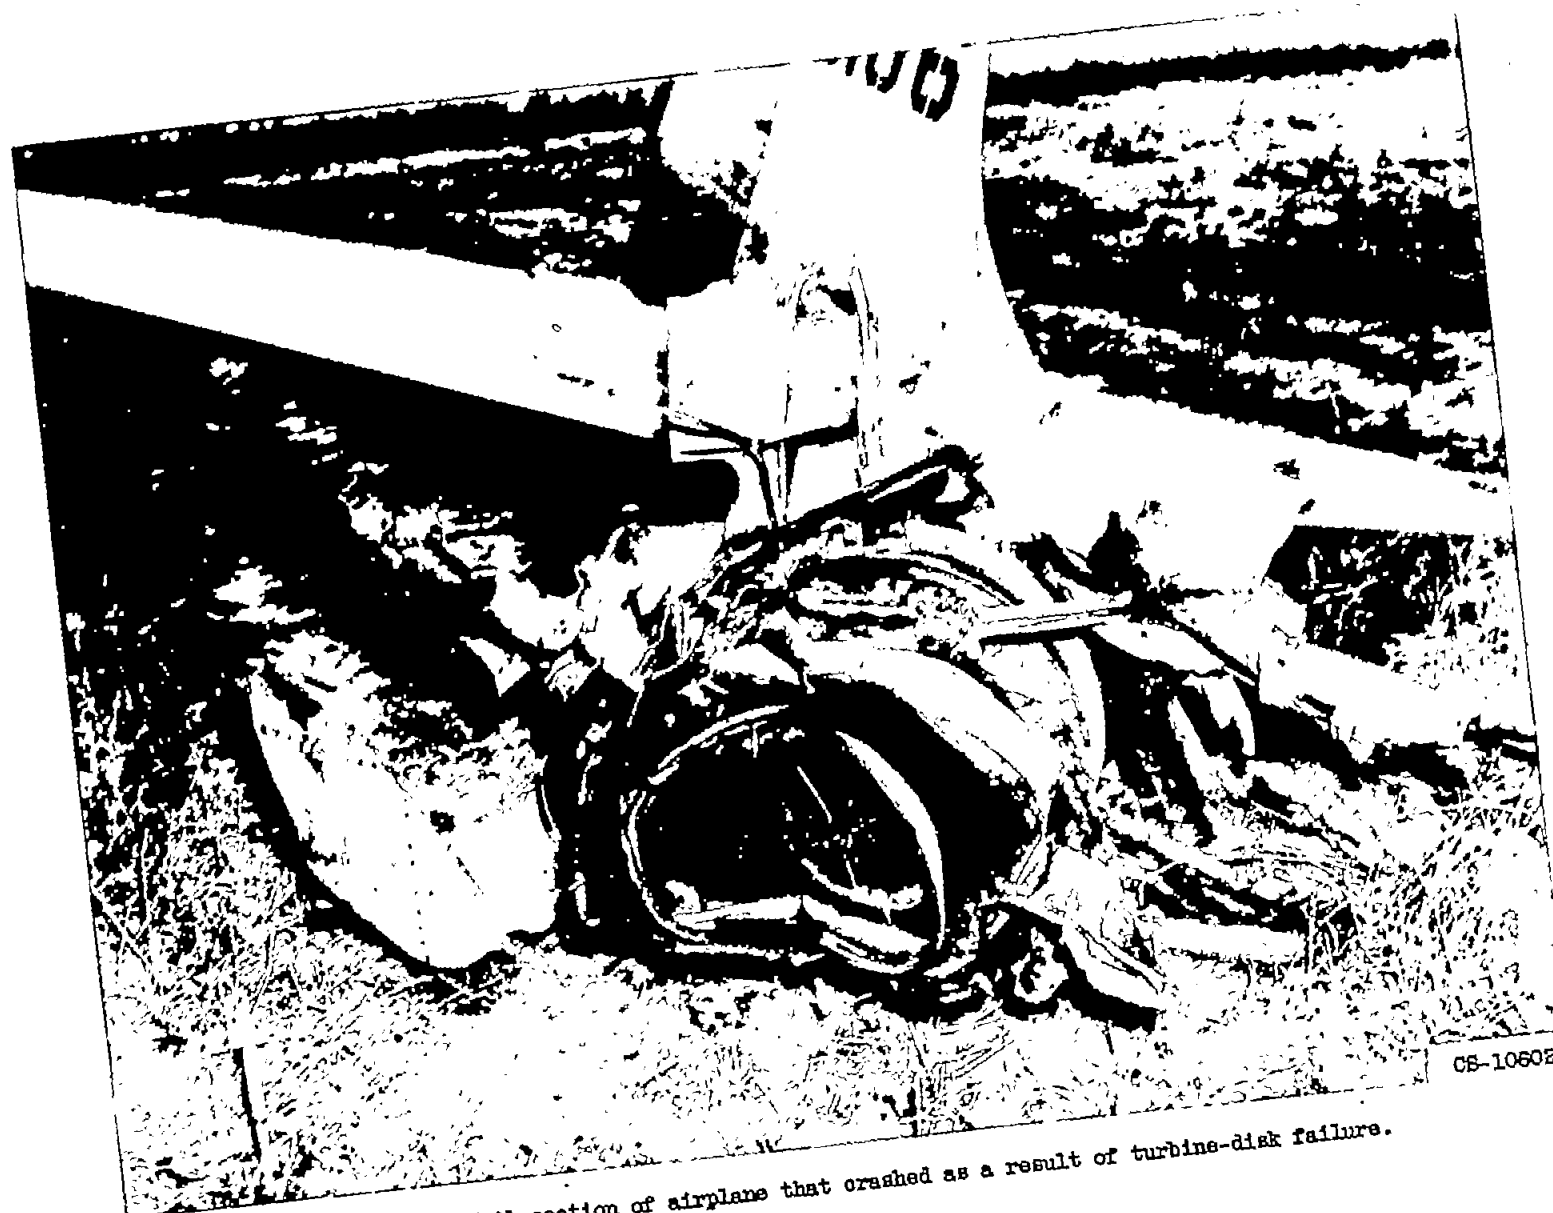
Figure 2. - Tail section of airplane that crashed as a result of turbine-disk failure.

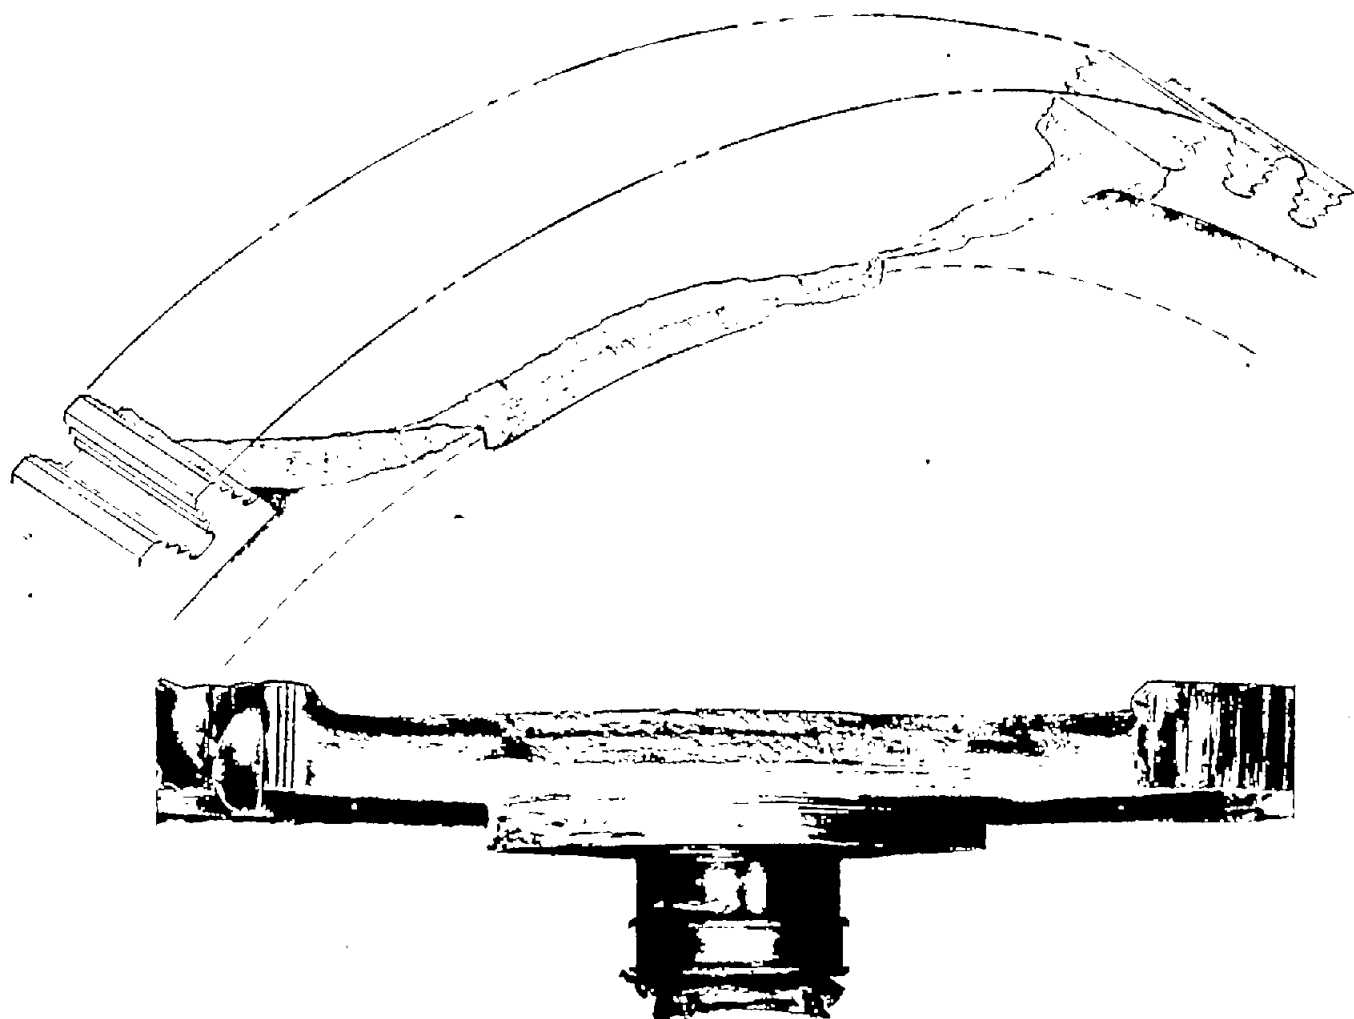
Figure 11. - Weld failure.

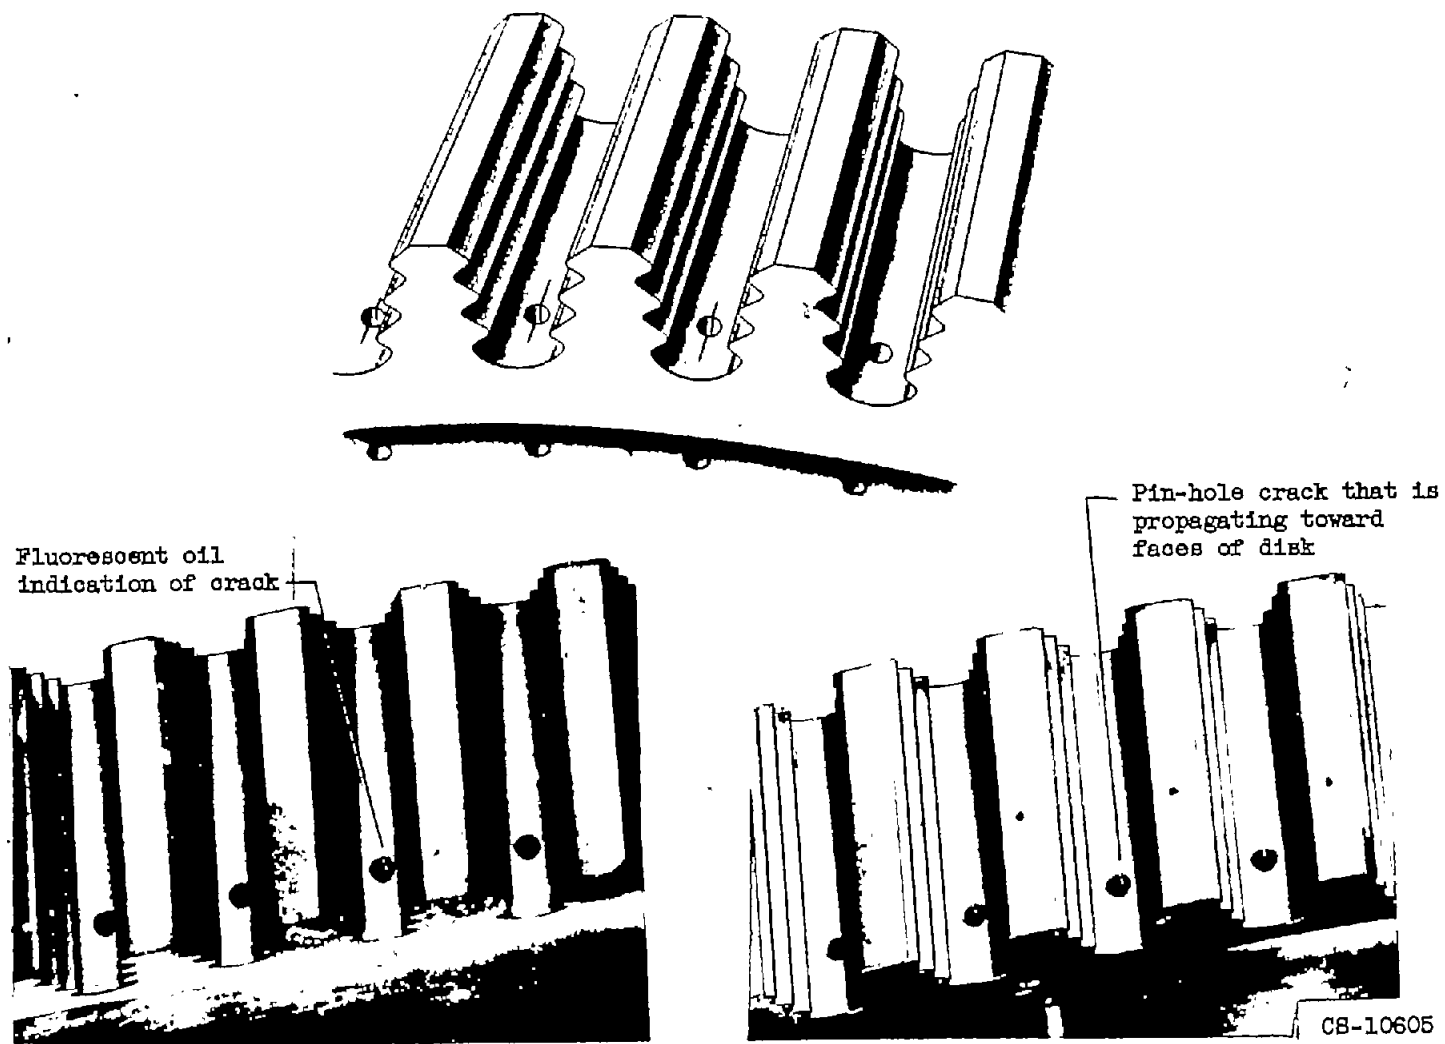
Figure 13. - Pin-hole cracks.

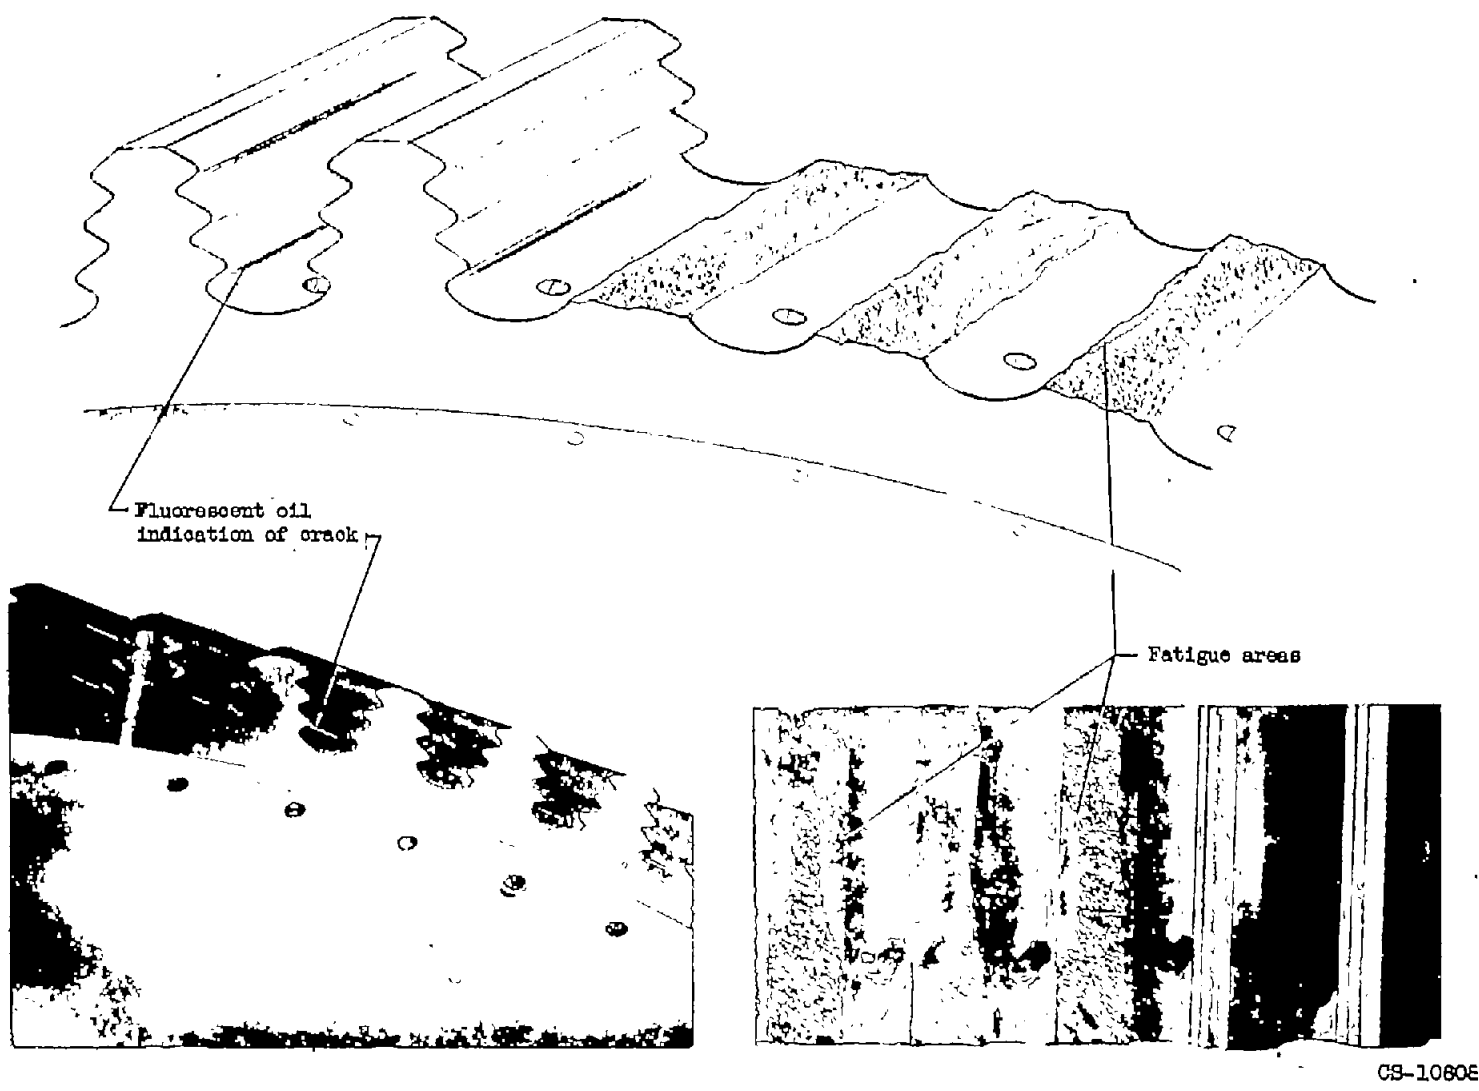
Figure 18. - Serration failure.

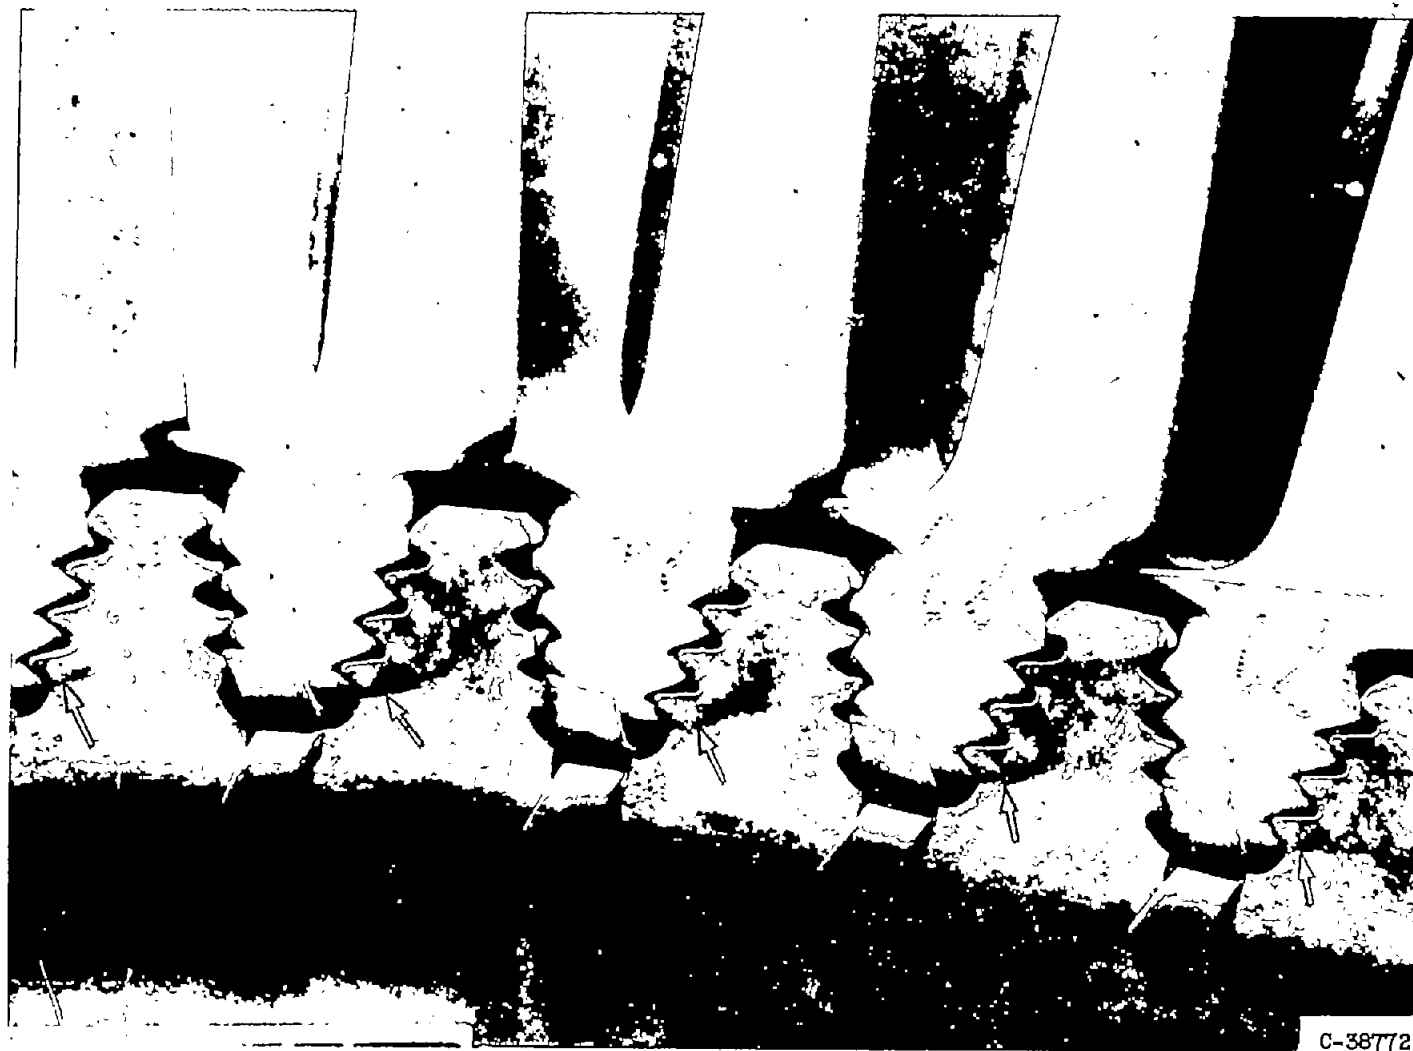
Figure 19. - Serration tensile failures resulting from nonuniform loading.

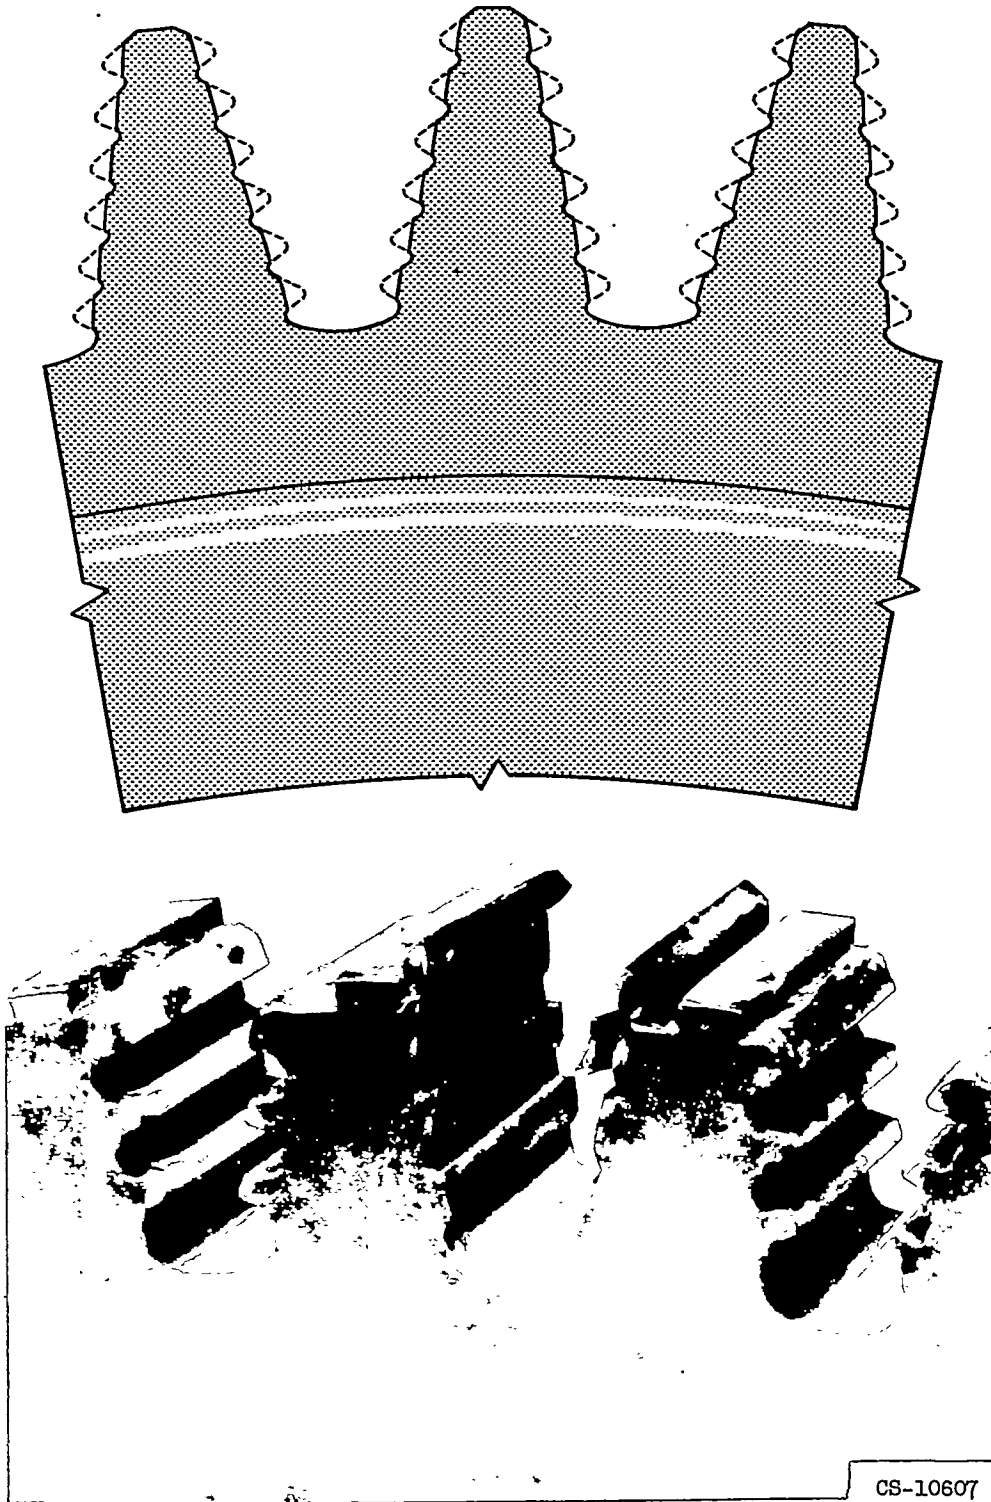
Figure 20. - Serration shear failure.

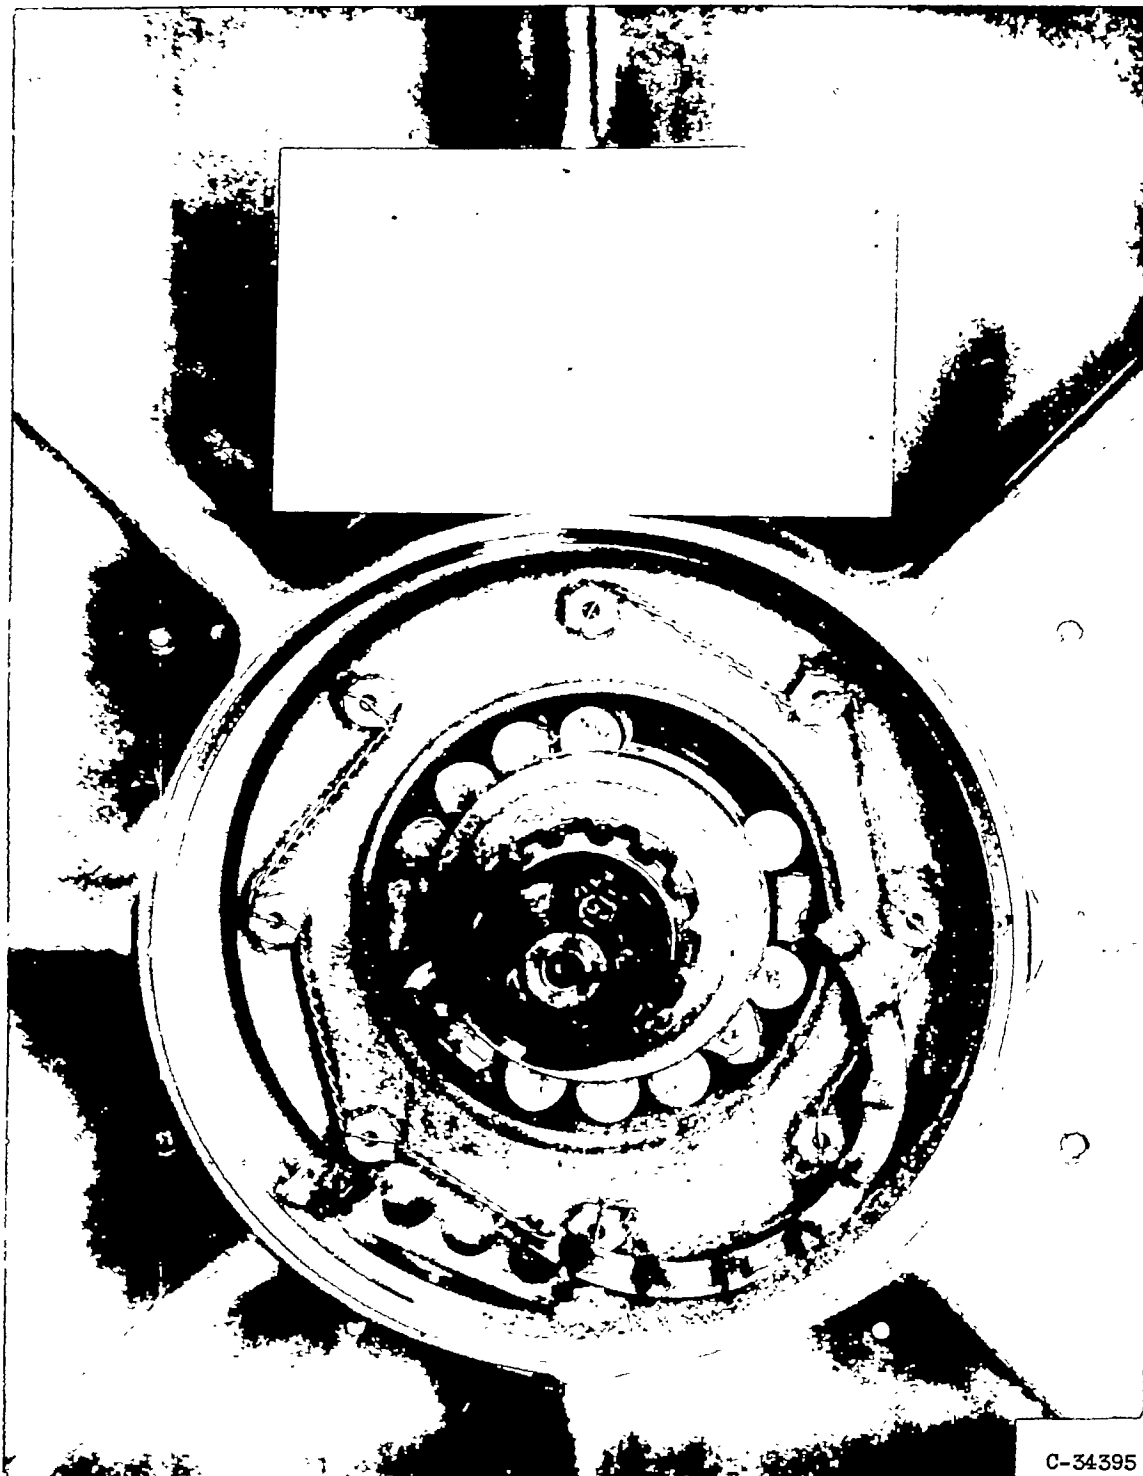
Figure 5. - Bearing failure resulting from oil interruption. Engine with jet lubrication of bearings. Photograph shows cage has failed completely. Failure occurred 17 minutes after the oil interruption. (From appendix B, ref. 1) Other photos of engine in figures 6 and 7.
